# Slate Roof Repair — Dos and Don'ts

Joseph Jenkins

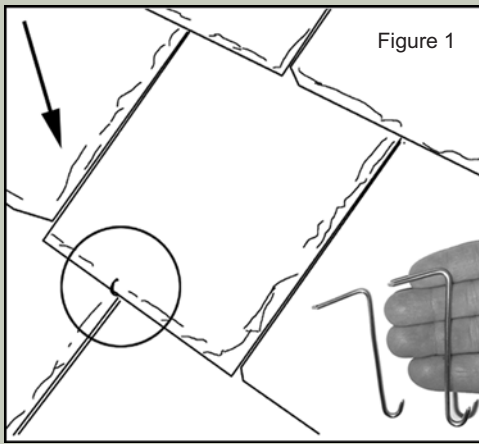
Figure 1

**Myth #4) *Install replacement slates by using copper straps that fold up over the bottom edge of the slate.*** False. Just because you've "always done it that way" is not an excuse to keep doing the wrong thing. There are two replacement techniques that are acceptable: slate hooks (Figure 1) and the nail and bib method (Figure 2). Exposed straps (Figure 3) look bad and will open up if anything sliding down the roof hits them (like snow).

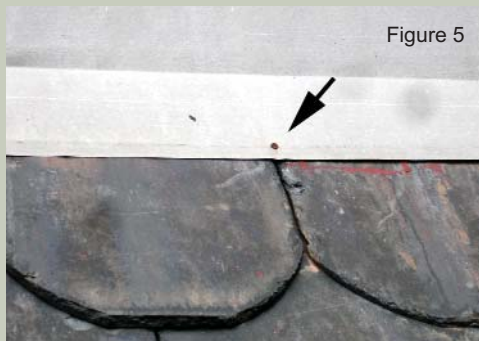
Figure 5 shows a common leak that is often overlooked. The exposed nail head on the apron flashing of the chimney will allow water to enter the building. Caulk the nail head. Next time, install the flashing with cleats (see TR6 for cleat info at traditionalroofing.com).

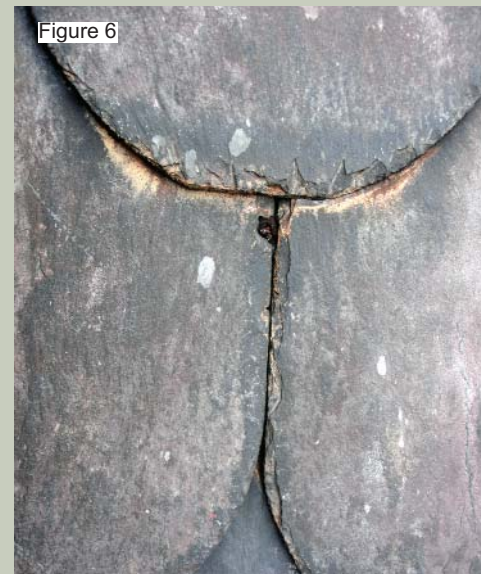
Figure 6 shows what I call a "hidden leak." There is a nail in the top of the slot where someone used the "nail and bib" method to replace the slate in the past. Figure 7 is a closeup of the nail. There is an old bib flashing there that completely rusted through, exposing the nail head. This allows water to directly enter the roof and shows why you should not use galvanized bib flashings (use copper, aluminum, or stainless). The reason this is a hidden leak is because it's hard to spot. When looking from above, it's virtually invisible, but it will seriously leak water. Remove the nail and bib and replace them with a new nail and a non-corrodible bib.

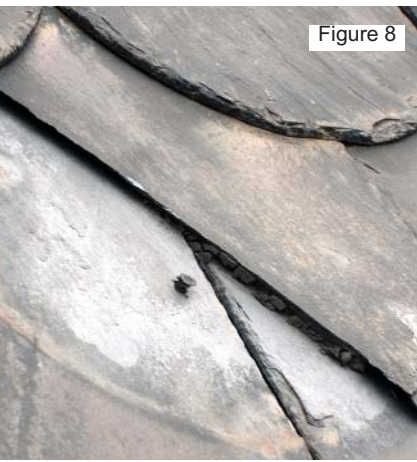
Figure 8 shows an obvious leak. The slate has split, exposing the underlying nail. Water will enter through the nail hole and through the slot between the slates. The broken slate must be replaced.

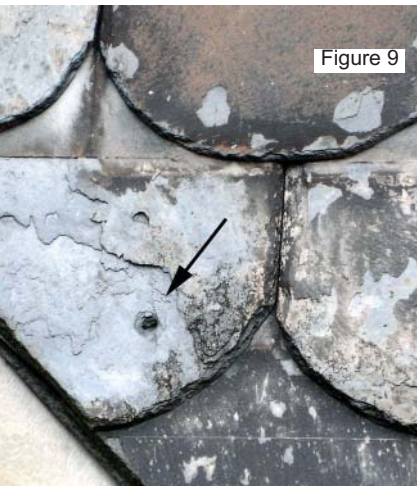
Figure 9 shows another leak that is fairly common. The nail head has rubbed against the overlying slate and worn a hole in it. The nail either wasn't nailed down far enough when the roof was originally installed, or else it was nailed into a knot or something that caused it to back out when the wood dried. This illustrates why standard-thickness slates should be punched rather than drilled for nail holes. The punching creates a crater shaped hole that will allow the nail head to sit inside the slate, preventing the rubbing effect that can damage the roof over time.

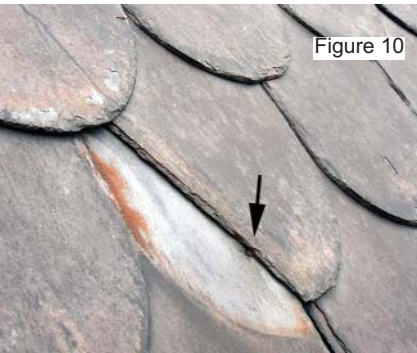
Figure 10 shows another broken slate, this time where the exposed nail is barely visible. The broken edge of the slate can channel the water directly to the nail hole, creating a significant leak. The solution is to replace the broken slate.

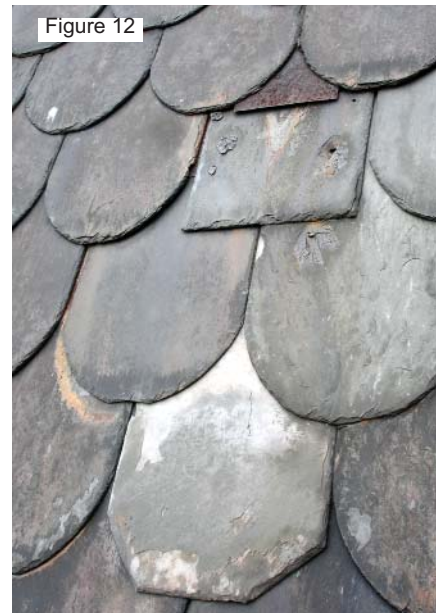
Figure 12 shows the sort of shoddy repairs that are commonly seen on older slate roofs. This is the sort of poor workmanship that slowly degrades a roof until it is ripped off by the owner in frustration and replaced with a cheap substitute. Anyone who hires someone who does this caliber of work should have his or her head examined. Unfortunately, slate roof repair work can be very difficult for a client to examine close up. Yet, replacement slates that don't match the original roofing in shape can be seen from the ground. Sometimes, this is the work of do-it-yourselfers or volunteers and is often seen on churches where well-minded but inexperienced congregation members with ladders decide they want to help.

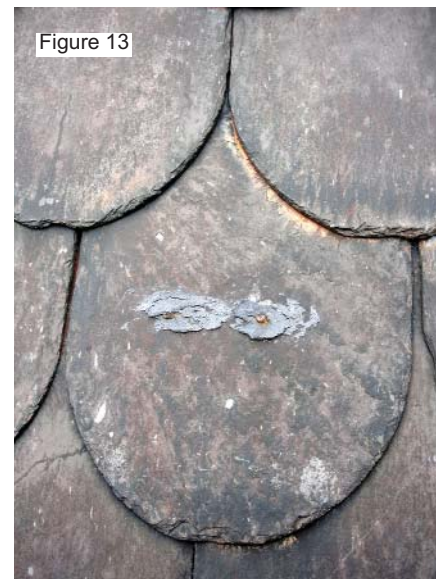
Figure 13 shows another common “repair” that actually causes more leaks than it fixes. The replacement slate was simply “face-nailed,” or nailed through the exposed face of the slate. Then that darned tar came out. It would have taken less time to use a nail and bib or a slate hook and replace the slate correctly.

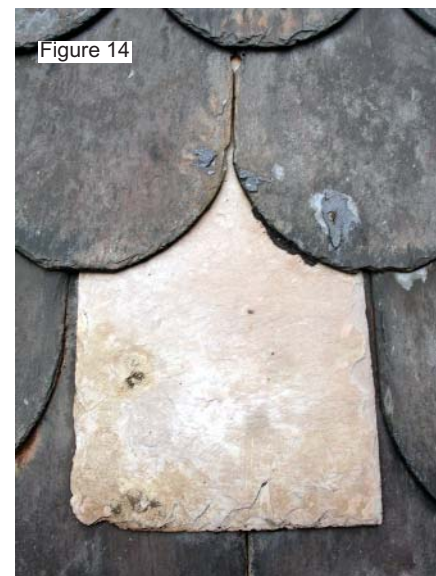
Figure 14 shows a repair done by an obviously blind roofer. The wrong shape and color of slate were used in the repair. When work is this poorly done, you can bet that the fastening method was off-base as well. Here's a tip: when a roof must be repaired and matching slates cannot be obtained, a section of the original roof can be “cannibalized,” or removed to acquire the needed matching slates. The cannibalized roof section should be one that is not very visible, like the side of a dormer roof on the rear of the building. Once the slates are salvaged, the removed section can be slated with either a salvaged or new slate. This technique also works well on unusual tile and asbestos roofs. A property owner will be happy to have a different shade of black slate, for example, on a rear dormer if the rest of the black slate roof on the building looks good, instead of a mishmash of unsightly repairs scattered across her roof.
